# Town of Arlington

## FINAL REPORT

### ADA Self-Evaluation (as basis for Transition Plan)

Prepared by  
Institute for Human Centered Design  
December 15, 2014

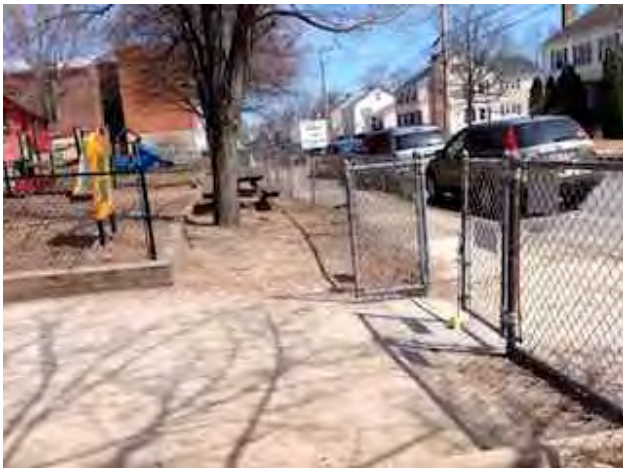
Photo 8

No-step gate to larger playground from Tufts sidewalk opening is too narrow and not along an accessible route. (Photo 8)

Replace double-sided gate to play area near parking with a one-latch gate with 48" opening. Add smooth plate or kickplate hardware on latch side. Mitigate ground surface cross slope issues on both sides of gate.

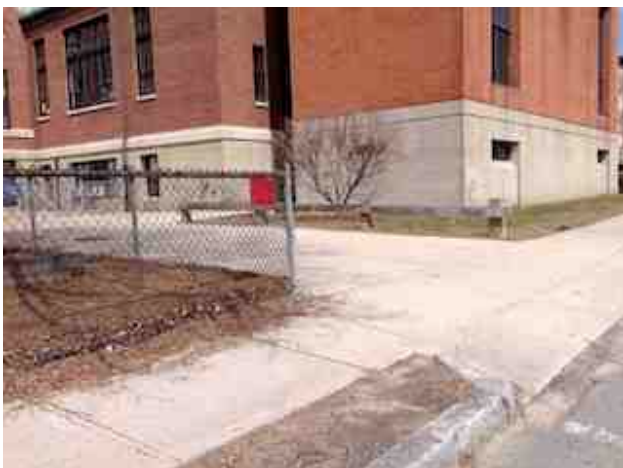
Photo 9

Walkway between Tufts St. and Foster St. passing inaccessible program entrance and picnic table area has vertical level changes over 1/2 inch unbeveled on Tufts St. side and curb ramp with excessive run slope (>13%) on Foster Street side. (Photo 9)

Signage posted on the fence pointing to the ramped entrance provides no clear and useable directional information. (Photo 9)

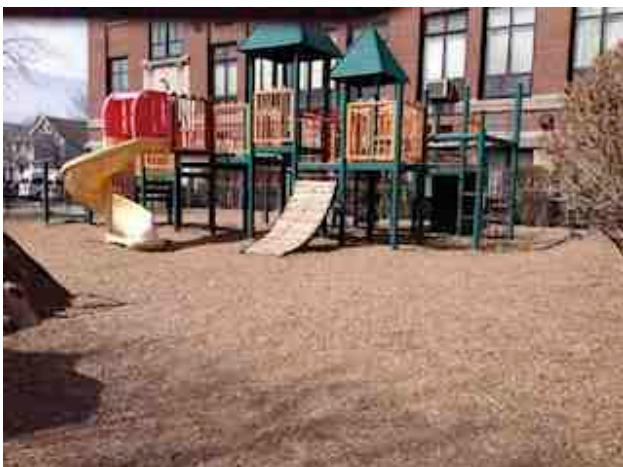
Photo 12

There are more than 20 elevated play components in larger play area and at least 25% are not connected by ramps. None of the ground play components are currently along an accessible route. (Photo 12)

a. If play area is altered, replace or replenish ground surface materials at both play areas. Recommend unitary ground surface materials, which will comply with both ASTM and Accessible Routes within Play Area

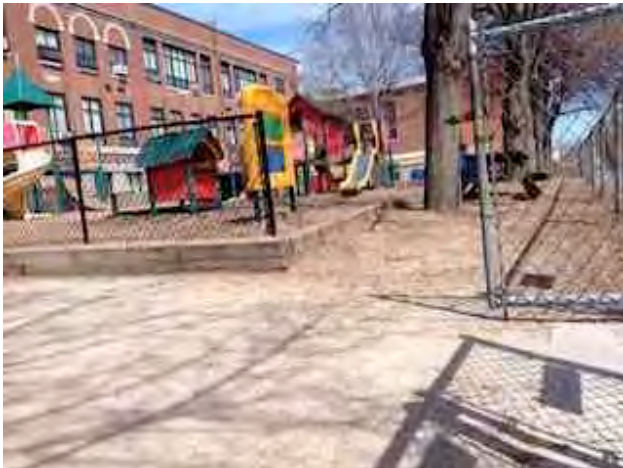
Photo 14

There are at least 5 inaccessible picnic tables around the perimeter of facility, and one picnic table within the larger play area. These are not located along an accessible route, or providing a clear location for users of wheeled mobility devices to sit. (Photo 14)

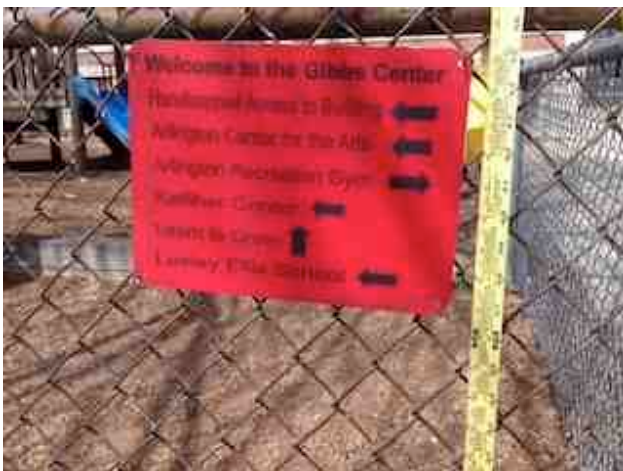
Photo 15

Directional signage mounted along fence around perimeter of facility provides unclear information. (Photo 15)

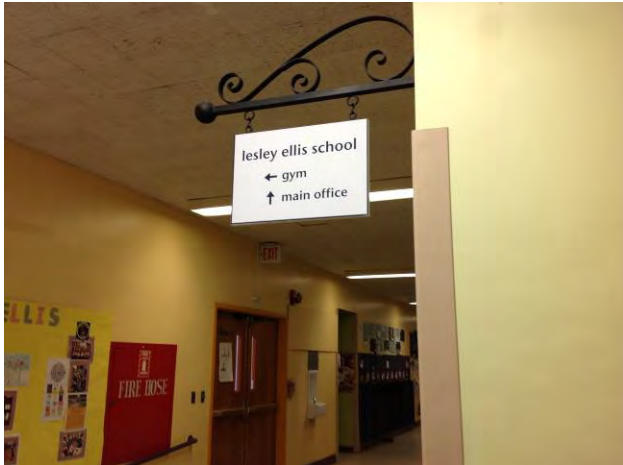
Photo 19

Within Gibbs Center, directional signage to Gibbs Gym is insufficient and poorly located. On level 1, no directory signs are offered at either entrance. Further, the only indication about the location of Gibbs Gym can on be found on the control panel inside the elevator. On level 2, the only directional sign to Gibbs Gym is found above the doors to the main office of Lesley Ellis School. (Photo 19)

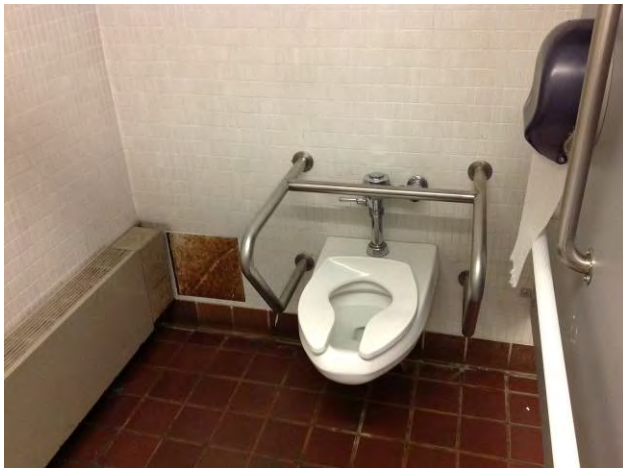
Photo 20

One set of multi-user toilet rooms (one for each gender) is provided near the elevator on level 1. Although these toilet rooms may have been code-compliant at the time of their installation, they do not meet the minimum requirements of either 1990 ADA Standards or the current accessibility laws and regulations. Toilet rooms are inaccessible because faucets are non-compliant, plumbing underneath lavatories are not protected, mirrors are too high (49" above the floor), paper dispenser are too high (52" above the floor), accessible toilet stall have non-compliant grab bars, and no alarms are provided. (Photo 20)

- Replace the faucets of at least one lavatory with ADA-compliant fixtures;
- Protect the plumbing underneath of at least one of the lavatories in each toilet room;
- Lower at least one mirror above a lavatory so that its reflective surface is no higher than 40" above the floor;
- Lower paper dispensers so that their controls are no higher than 48" above the floor;
- Replace grab bars with ADA-compliant accessories inside the accessible toilet stalls;
- Install audible and visible fire alarms.

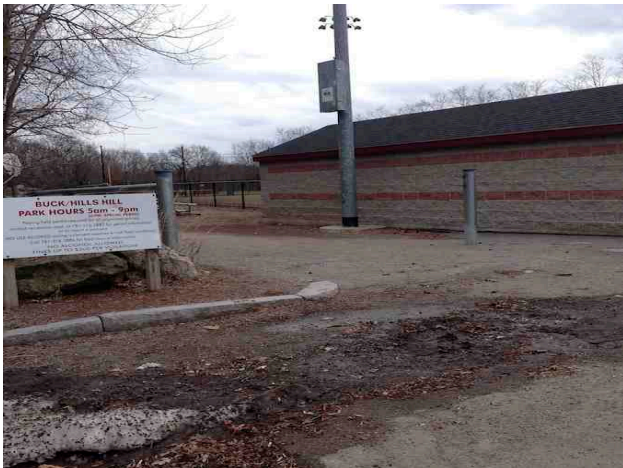
Photo 2

The point to entry that includes facility signage is shared with Buck Field. This entrance is uneven and needs maintenance. (Photo 2)

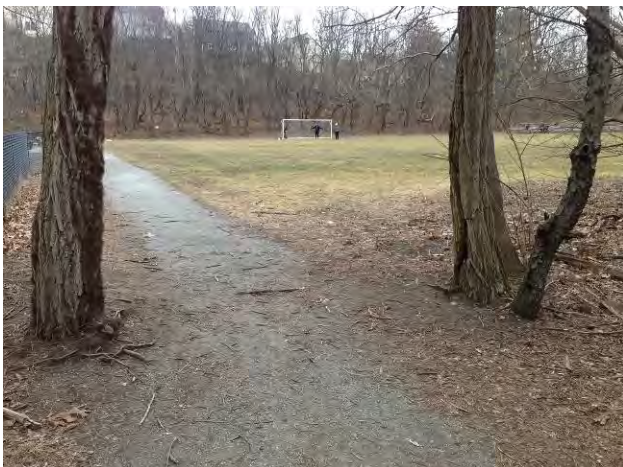
Photo 3

The point of entry from the Bikeway Shared-Use Trail is a well-graded stone dust pathway. (Photo 3)

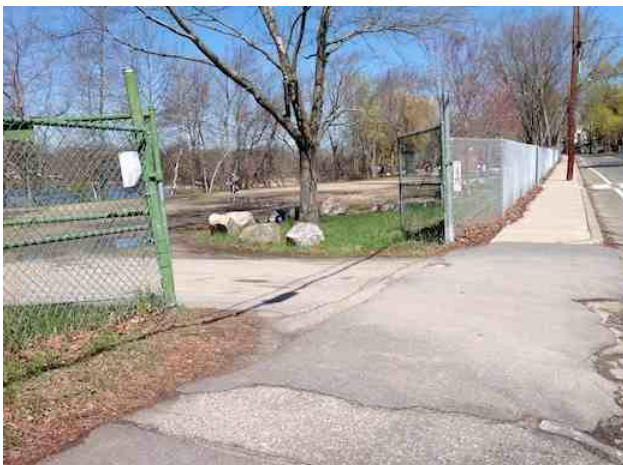
Photo 3

Sidewalk along Westmoreland perimeter fence needs maintenance. The pedestrian zone is not blended to level and smooth at parking lot entry point. Sidewalk has excessive cross slopes. (Photo 3)

Lowell St: Replace sidewalk panels that have gaps, uneven terrain and cross slopes exceeding 2.08% along the sidewalk adjacent to Lowell St. pedestrian entry points.

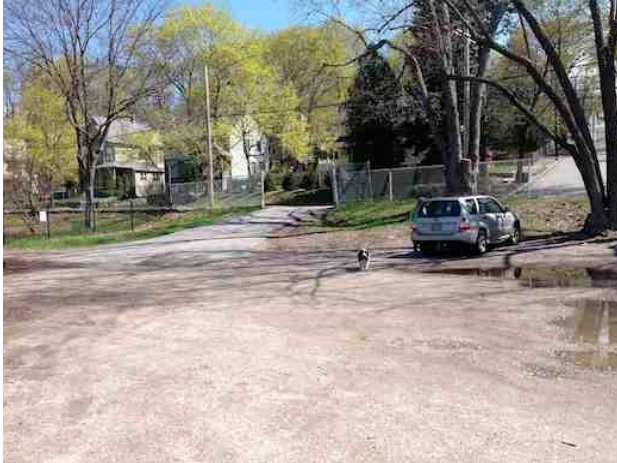
Photo 4

The seasonal public parking lot on Lowell Street is not striped, does not include accessible parking spaces or an accessible pedestrian surface. Water pooling and cross slope issues were found. (Photo 4)

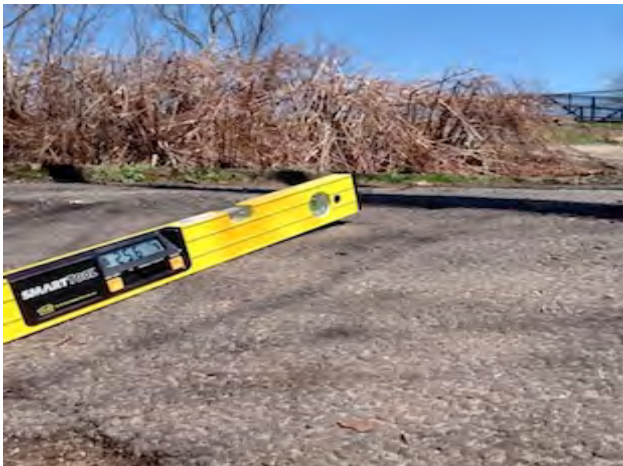
Photo 8

Secondary trails branching off the trail to Wildlife Garden and in the direction of Hurd Field are excessively steep and are not usable until they can be re-graded to minimal slopes with additional natural wall (or handrail) supports. (Photo 8)

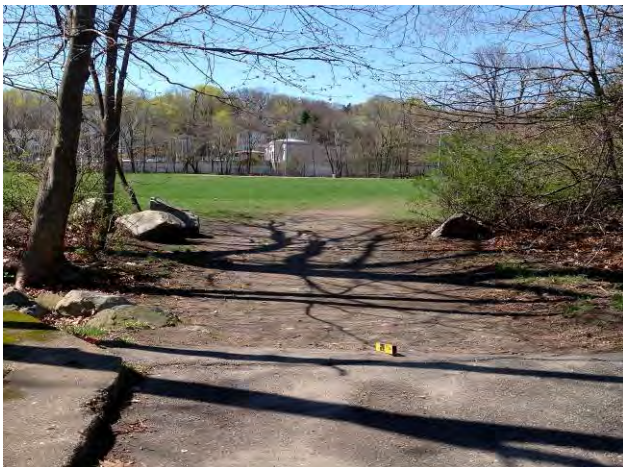
Photo 9

The informal trail between the back of Hurd Field and the Reservoir Trail at the spillway bridge is particularly hazardous and does not provide an accessible connection between the two sections of this multi-use facility. (Photo 9)

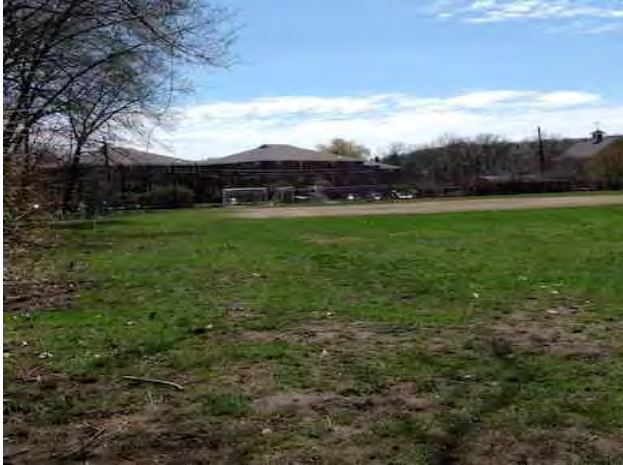
Photo 10

There are no accessible path connections between the paved parking lot and perimeter of field playing areas. There are no accessible paths and firm, smooth ground surfaces to and within the team meeting and seating locations. (Photo 10)

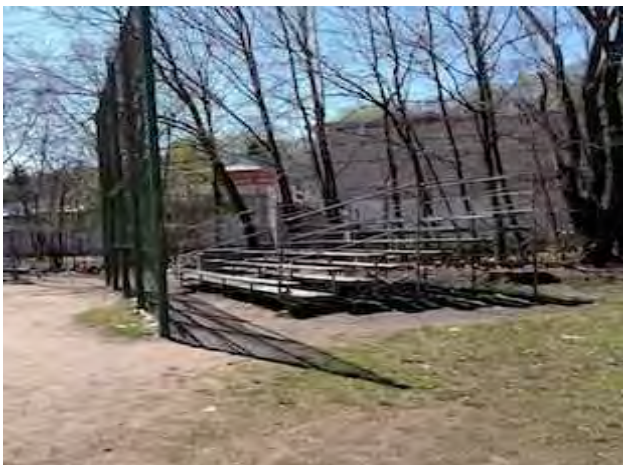
Photo 12

There are no accessible route connections to the spectator bleachers at the larger Hurd Field ball field at this time. These are not accessible bleachers and there is no clear, firm and level ground spaces provided for wheelchair spectator locations. (Photo 12)

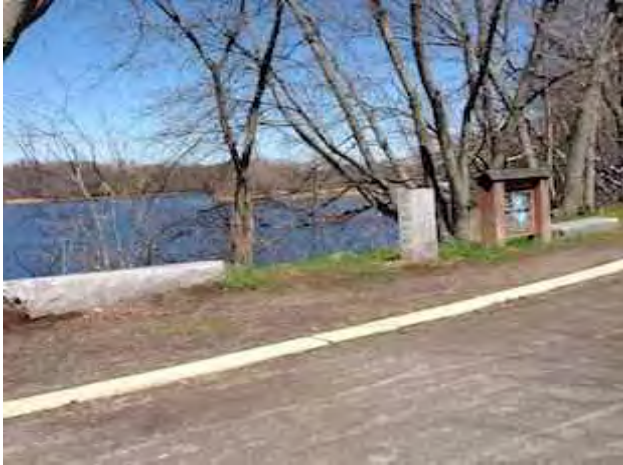
Photo 13

The sign explaining the EPA Porous Pavement project at the Drake parking lot; and the Map installation at the Lowell St. Trail entry point do not provide accessible clear ground approach and viewing conditions due to mounting heights (EPA sign) and distance from trail edging (Map). (Photo 13)

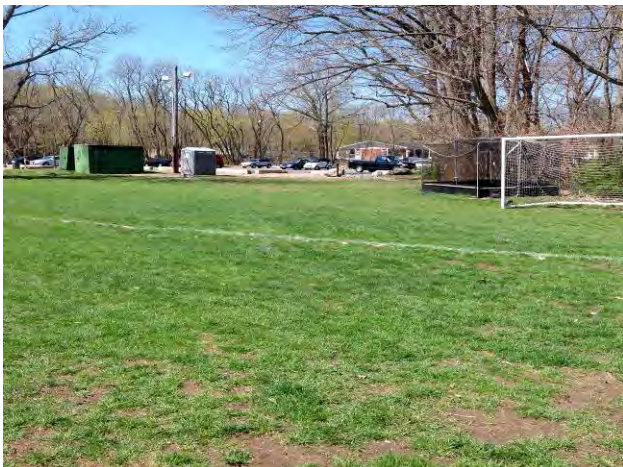
Photo 15

A portable toilet installed at the edge of Hurd Field is not adjoining an accessible path and does not provide an accessible level, firm ground surface for entry. (Photo 15)

Relocate the portable toilet along the existing walkway or extend the asphalt walkway to it (about 5 feet).

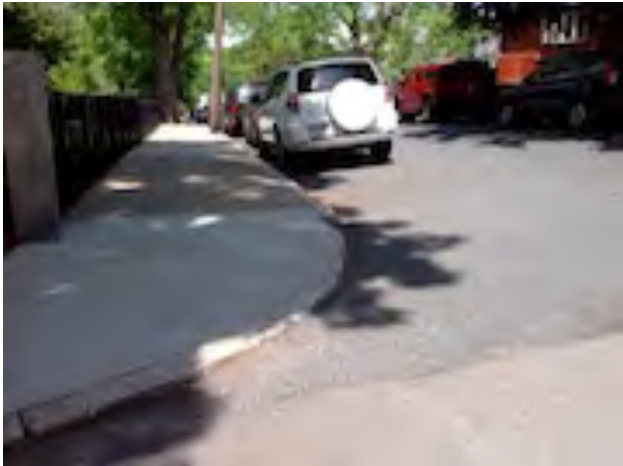
Photo 2

Curb ramps at intersection of Paul Revere Road and Davis Ave. are inadequately constructed, with excessive run slopes, no flared sides, and a non-gradual transition to street. (Photo 2)

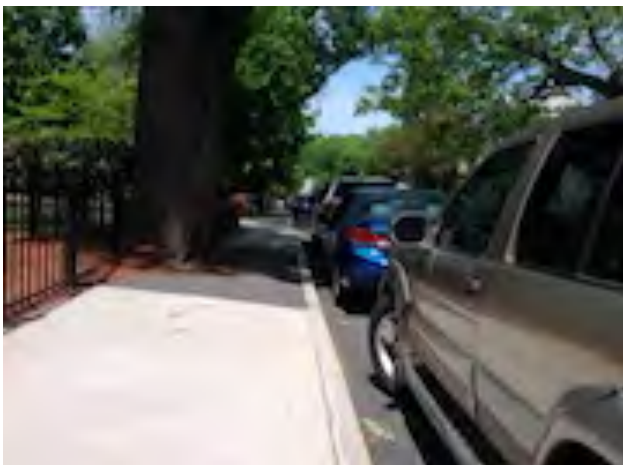
Photo 3

Sidewalk panels from Paul Revere Road down Davis Ave. to the Park have been sporadically replaced. New and older sidewalk panels have noncomplying cross slopes. (Photo 3)

When future sidewalk alterations are made to Davis Road, reevaluate and replace panels to ensure consistent cross slopes to the maximum extent possible.

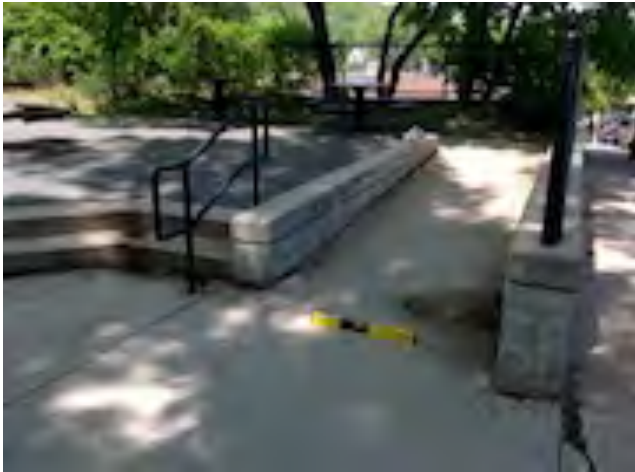
Photo 5

Facility has one entrance. There is a friendly foyer-type presentation leading to a two-step staircase on the left, and a matching accessible ramp to the right. (Photo 5)

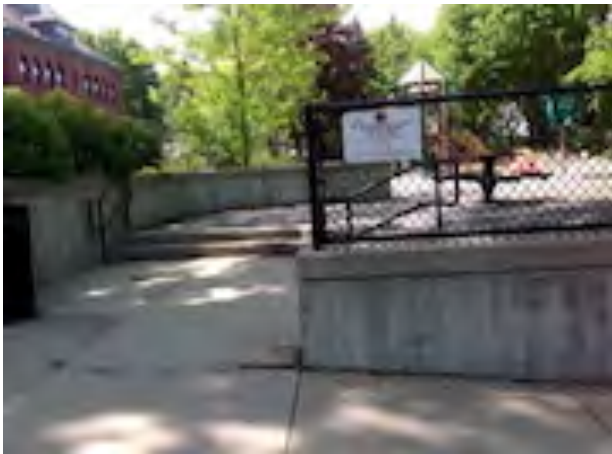
Photo 6

Entryway panels have some minor cross slope issues. (Photo 6)

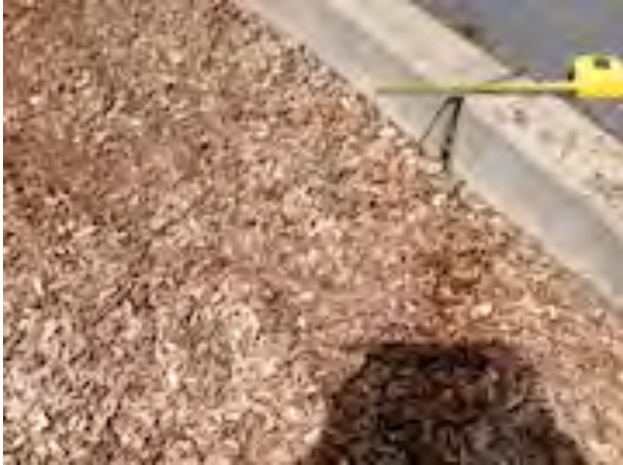
Photo 10

There is not yet an accessible, level connection between the ground surface of the recessed play areas and the adjacent cement walkways.

There is not yet an accessible, level connection between the ground surface of the recessed play areas and the adjacent cement walkways due to the high borders around the compacted loose fill surfaces. (Photo 10)

b. If ground surface materials will be replaced: consider resurfacing all or portions of the recessed play areas with unitary surface materials that are resilient and also provide accessible levels and firmness.

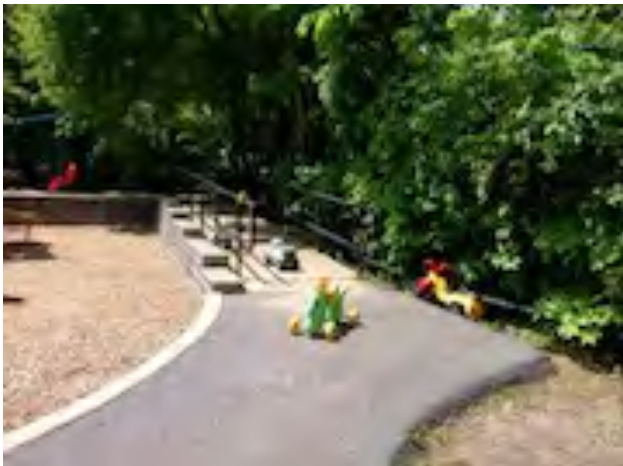
Photo 11

The lack of a level entry/exit into the recessed play areas on both levels prevents an accessible route connecting the bottom and top of the slides, despite the walkway ramp connection just out of level reach. (Photo 11)

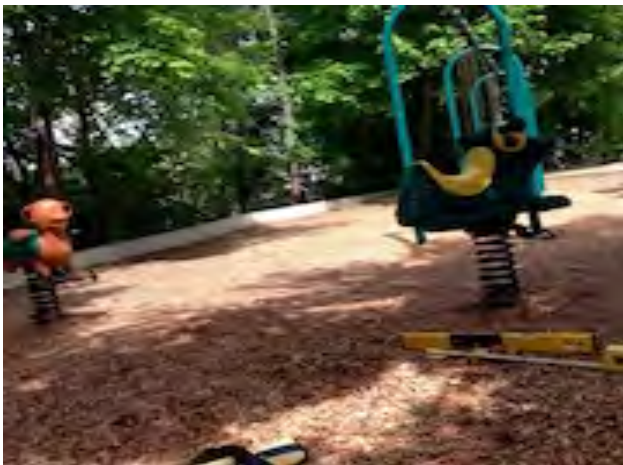
Photo 12

Although the loose fill ground surface materials may provide adequate impact attenuation conditions, these materials are not currently maintaining minimal slopes and the firmness needed for accessibility conditions. (Photo 12)

a. If loose fill ground surface materials are still used, a high-frequency maintenance policy needs to be implemented to ensure accessible routes in recessed play areas through all seasons.

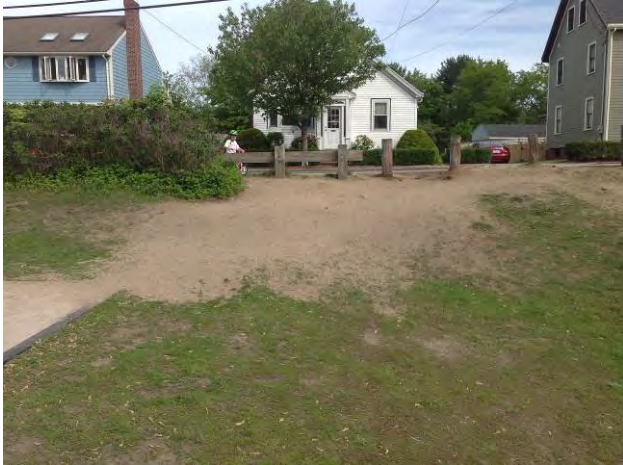
Photo 1

Due to the lack of another option, the walkway leading to the playground on North Union Street has been used by the public as a *de facto* point of entry to this facility. (Photo1)

- 1 Points of Entry:** While a section of this facility is closed for renovations, provide a temporary accessible point of entry on North Union Street. At each stairway leading to the fields, install an ADA-compliant sign directing the public to the accessible point of entry.

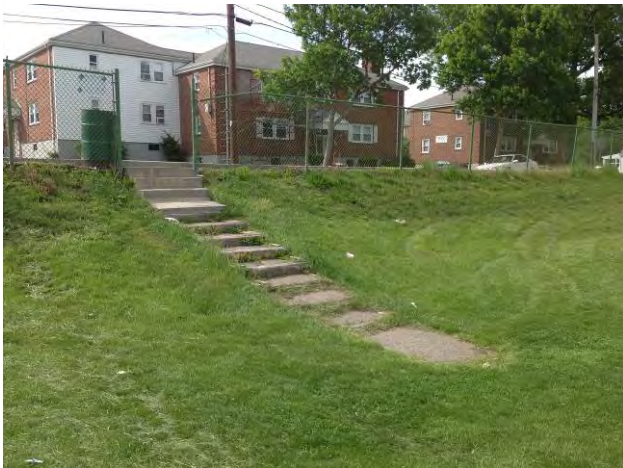
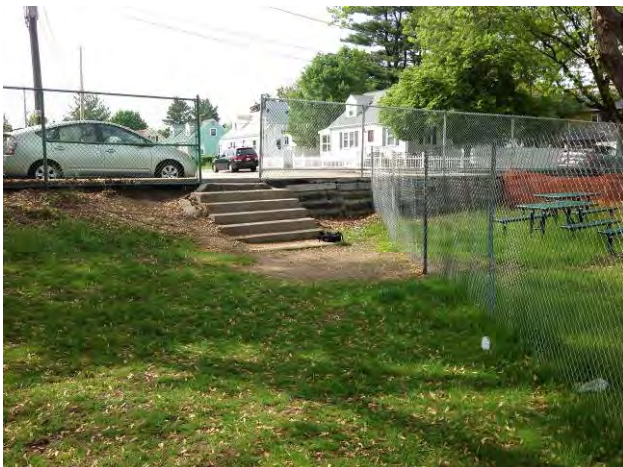
Additionally, neither of the stairways on North Union and Everett Street have compliant railings on both sides. (Photos 2 and 3)

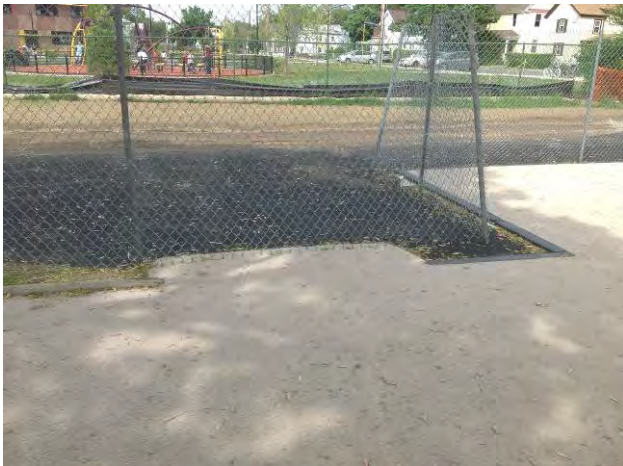
Photo 5

Due to construction, no accessible route is currently provided to the playground. (Photo 5)

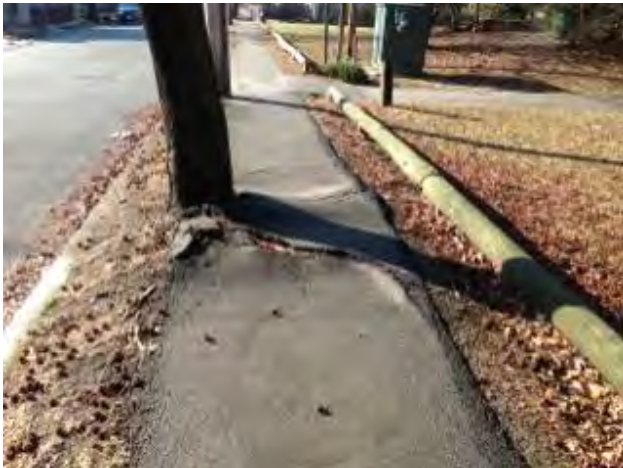
Photo 2

Although the sidewalks along Herbert Road and the Minuteman Commuter Bikeway are mostly accessible, the sidewalk along Thorndike Street is in poor condition. Not only are a few sections near trees extremely deteriorated but also the sidewalk has excessive cross slopes. (Photo 2)

Repair the sidewalk along Thorndike Street (about 300 feet).

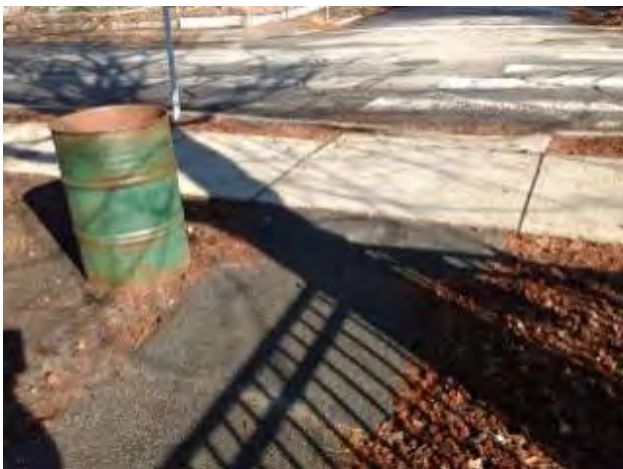
Photo 3

This facility has four at-grade points of entry: two on Herbert Road, one on Thorndike Street, and one along the Minuteman Commuter Bikeway. On Herbert Road and on Thorndike Street, the asphalt walkways at the edge of the sidewalk have excessive slopes (15.5% and 14%, respectively). (Photo 3)

Further, on Herbert Road, the gate that leads to the small play structure is not accessible because it lacks an ADA-compliant latch and kickplate.

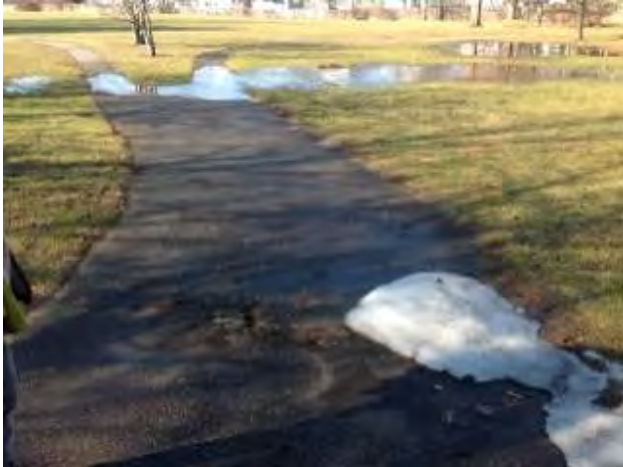
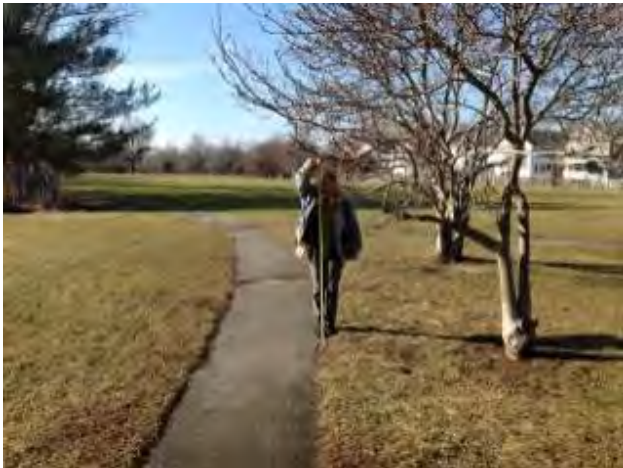
Additionally, between the points of entry at Thorndike Street and the Minuteman Commuter Bikeway, the asphalt walkway has sections that are too narrow (less than 36" of width) and is obstructed by deteriorated surface and tree canopies that protrude within the necessary vertical clearance needed along the pedestrian path. (Photos 4 and 5)

Between the points of entry at Thorndike Street and the Minuteman Commuter Bikeway, repair and widen the asphalt walkway to 48" of width (about 575 feet) and trim trees so that branches over the path are no lower than 80" above the ground.

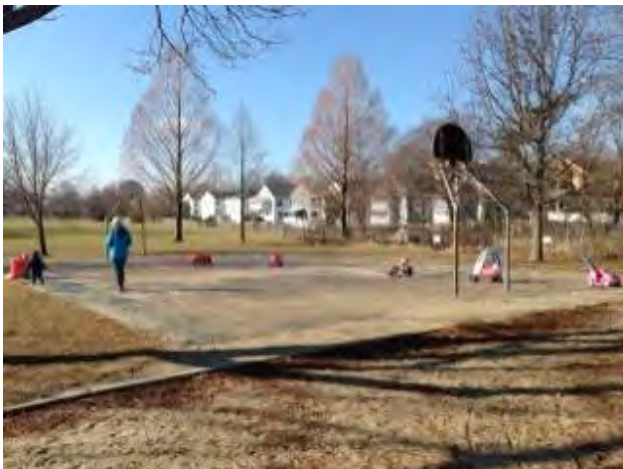
Photo 6

Although an asphalt walkway is provided between the points of entry and certain features in this facility, no accessible route is provided between the asphalt walkway and the basketball court. (Photo 6)

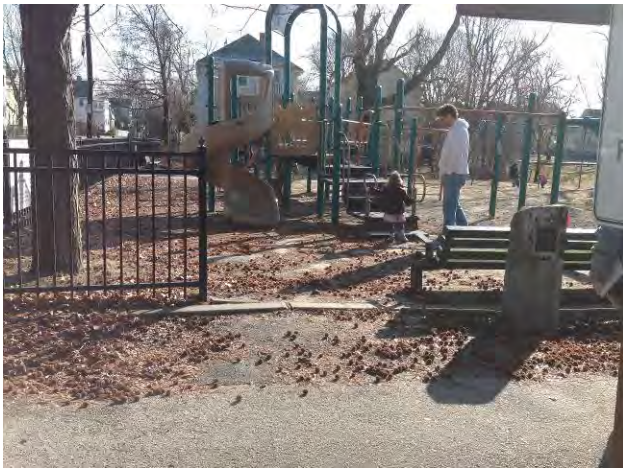
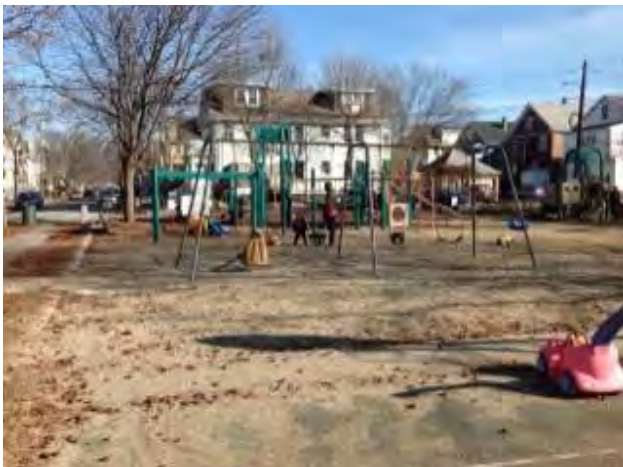
One large sandy area contains separate zones of play structures. Although an accessible route is provided to the small play structure on Herbert Road and the swingset adjacent to the asphalt walkway, no accessible route is provided to the rest of the playground. (Photos 8 and 9)

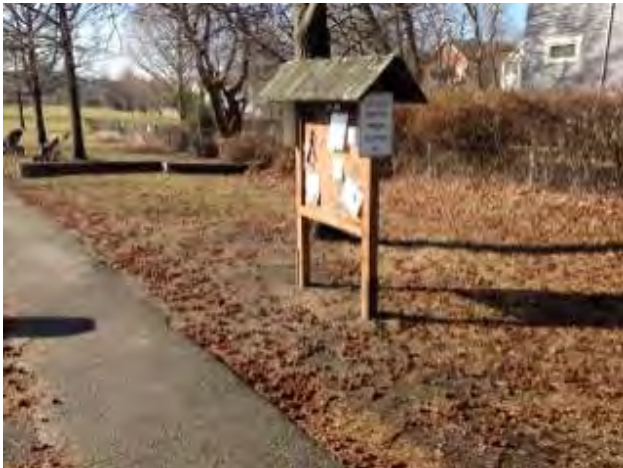
Photo 11

A bulletin board is provided near the point of entry at Herbert Road; however, a level, clear viewing area is not provided in front of the bulletin board and the adjacent paved circulation route does not yet include continuous accessible conditions. (Photo 11)

- 1 Bulletin Board:** Although not a requirement under the ADA, consider extending the asphalt walkway to the bulletin board.
- 1 Community Garden:** Completely re-configure the community garden so that accessible routes as well as planter beds at an accessible height and other features are provided within the garden.

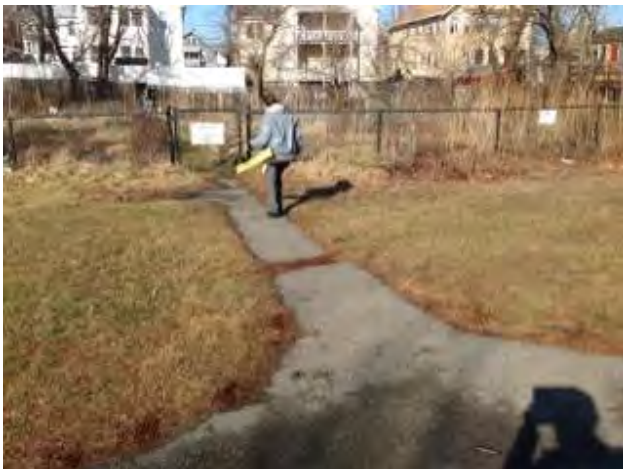
Photo 12

A gated community garden is provided near the point of entry at Herbert Road. Although the asphalt walkway connects this amenity to the rest of the facility, no accessible route or features, including an accessible gate, are offered within the garden. (Photo 12)

Completely re-configure the community garden so that accessible routes as well as planter beds at an accessible height and other features are provided within the garden.

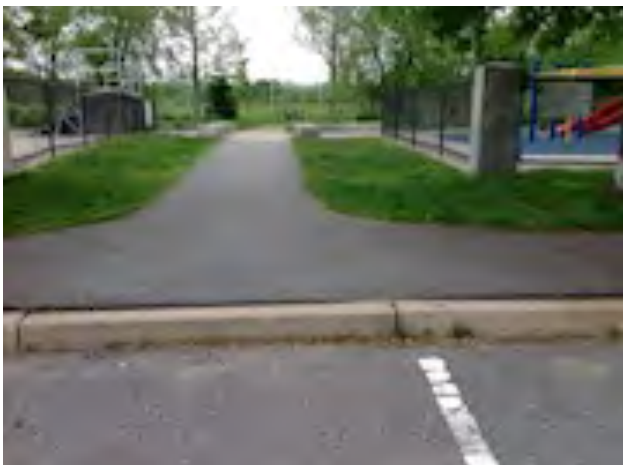
Photo 3

Sidewalks around the first parking facility are in good condition, but the smooth asphalt ground surface materials stop at the crossing between the Skateboard Park and playground. At this crossing and leading further into the grassy areas, the ground surface materials are embedded small cobblestone brick and stone dust. (Photo 3)

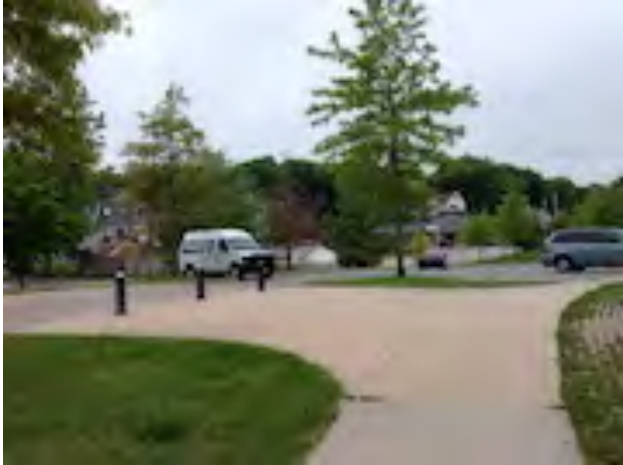
Photo 4

The first parking area has 48 spaces with two designated as accessible and sharing an access aisle. The walkway from these spaces has excessive cross slopes; and does not provide an accessible route to the points of entry leading to the skateboard park, between the park and the playground, or into the playground. Uneven surfaces, and excessive slopes impede the route from the designated parking spaces to the asphalt walkway into the playground.

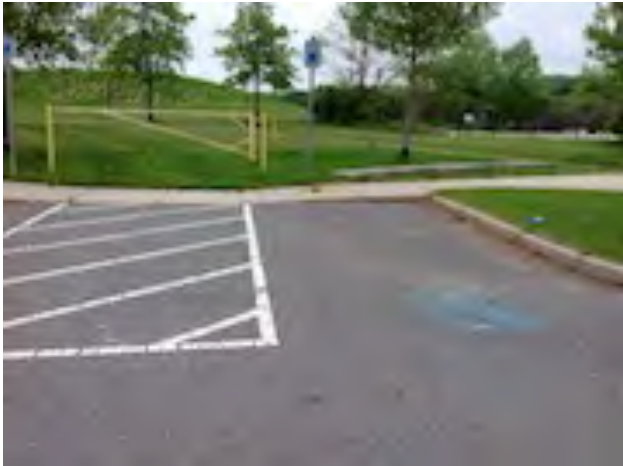
Photo 5

The second parking area has 27 parking spaces with two designated as accessible. These spaces share an access aisle, which leads to a walkway with excessive run slopes covered by hard tactile tile surfaces on both sides of the sidewalk adjacent to the access aisle. These sidewalk panels should not be treated as a curb ramp but rather, as a walkway. If the terrain cannot be regraded to maximum 5% slopes, then handrails should be added and this portion of the walkway treated as a ramp (not as a curb ramp).

The interior walkway leading to the sitting area between the two play areas is the only walkway that provides a continuous accessible route into a facility area; however, this walkway is not connected along an accessible route to the designated accessible parking spaces. (See Photo 5, previous page)

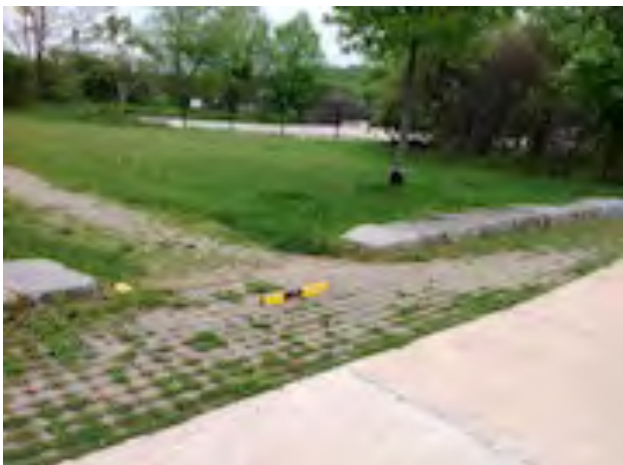
Photo 6

From the parking facility, there are four points of entry into different program areas leading into field walkway, picnic area, between skateboard park and the playground, and to sitting area within playground area. Only the walkway into the playground sitting area is accessible (Photo 6)

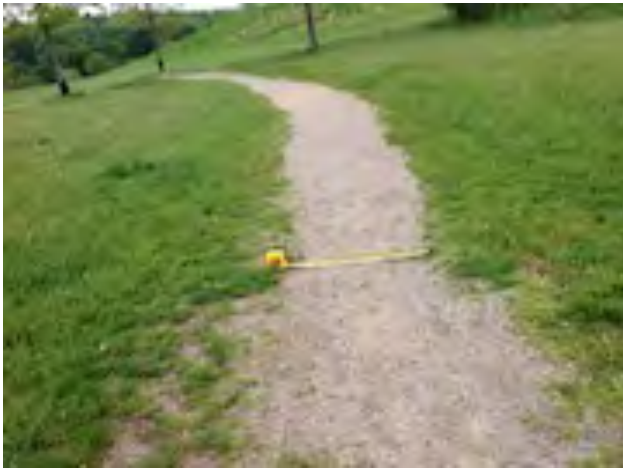
Photo 8

Walkways include narrow stone dust paths leading to the main interior circulation path around the fields and to Reed's Brook. (Photo 8)

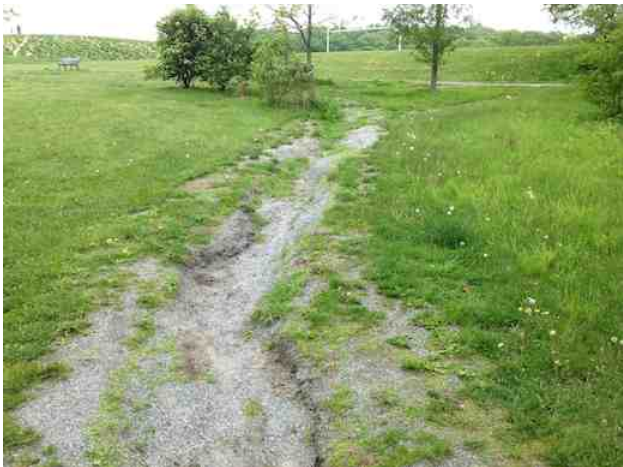
Photo 9

The circulation route around the fields and adjacent to Reed's Brook is uneven. Stone dust paths have eroded and dirt pathways do not hold accessible slopes and are not level. (Photo 9)

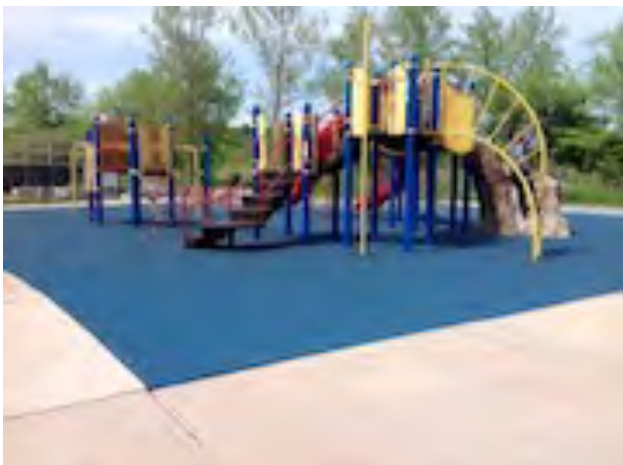
Photo 12

The large play area for older children has at least twenty play components total, and no elevated accessible route. The transfer system requires many steps to reach elevated play components. The trampoline is also accessed by steps or by climbing over the rim, which is a reach of over one foot. There are no accessible elevated routes to reach the mostly elevated play components. (Photo 12)

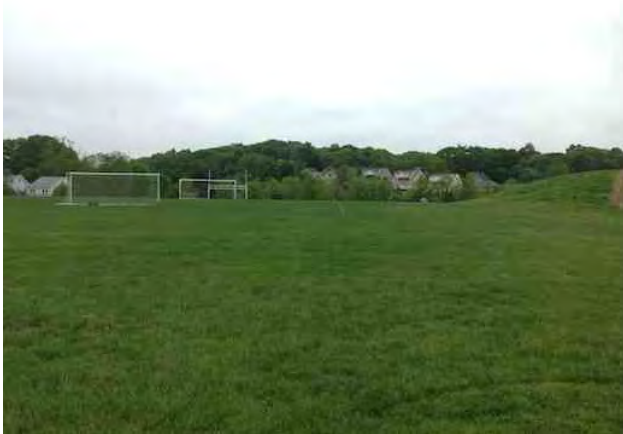
Photo 13

Although the fields on the eastern portion of facility have dirt paths leading to perimeter to fields, these paths require maintenance to be level, firm and slip-free. The middle and western open and soccer fields do not include an accessible route to perimeter of playing areas. (Photo 13)

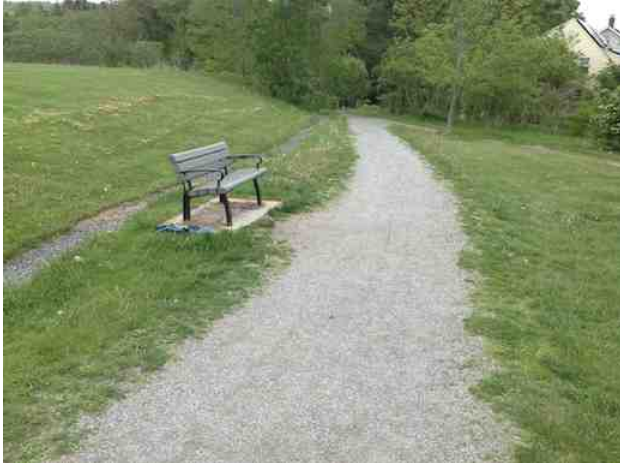
Photo 16

There are at least 8 benches with armrests provided along interior walkway. None are accessible because they are not located along an accessible route. None have clear, firm level ground space provided within the concrete pad for integrated wheelchair seating. (Photo 16)

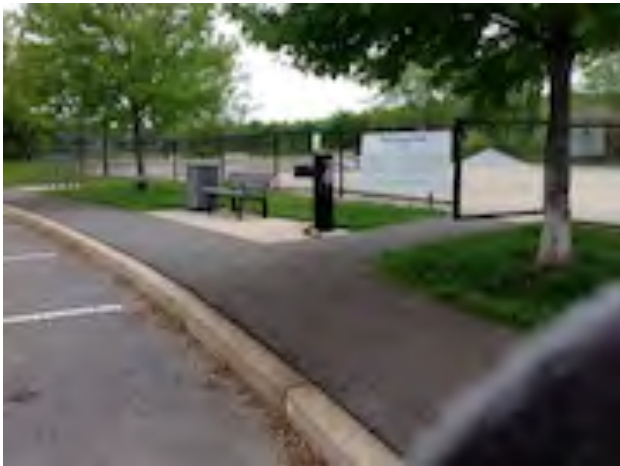
Photo 17

Benches with backrests and armrests are provided along parking facility walkways on either side of points of entry to facility. Although there is a clear space adjacent to the bench near the drinking fountain and adjacent to the skatepark gate, it overlaps with the space needed for a forward approach to the lower fountain amenity and to read the skateboard rules sign. (Photo 17)

Although this fountain has accessible heights, knee clearance and controls for forward approach, the clear floor space is not smooth and level due to dissimilar ground surfaces on approach. (Photo 17)

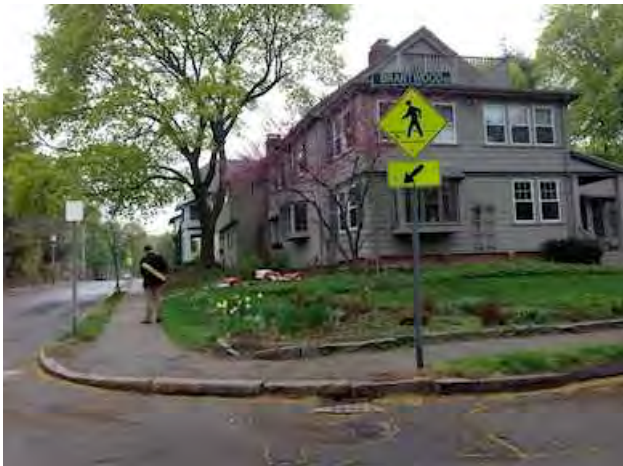
Photo 2

Curb ramps are missing at junction of Brantwood Rd & Jason St. (Photo 2)

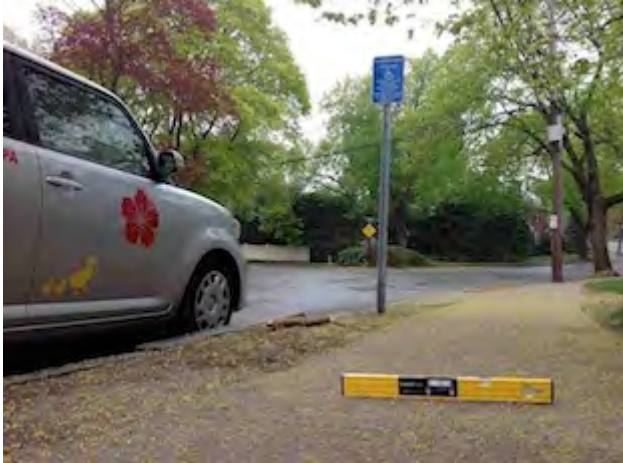
Photo 4

A designated accessible parking space is located close to facility entrance. The sidewalk and ramped driveway adjoining this space do not have accessible run or cross slopes. (Photo 4)

If roadway profile grade crowns at 5% or less, reconstruct sidewalk panels from parking sign to facility entry way with compliant run and cross slopes. If topological issues make walkway run slope compliance infeasible, seek a MAAB Variance for the noncomplying run slopes and replace sidewalk panels from sign to edge of narrow entrance with least possible cross and run slopes.

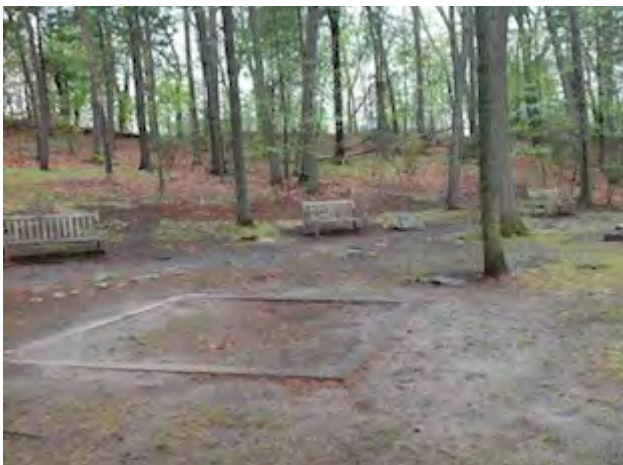
Photo 8

There needs to be at least 1 accessible pathway connection from trail to the picnic area's 2 accessible tables; and in addition, a connection needs to be established between trail and the Woodhenge circle. (Photo 8)

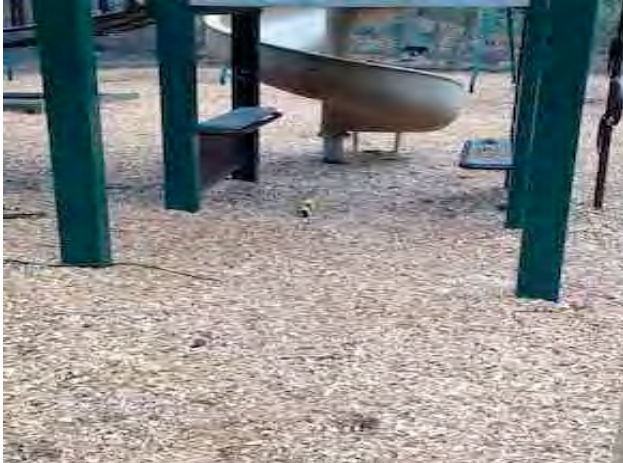
Photo 9

The bordered playground is surfaced with loose-fill ground surface materials.

These surface materials may fulfill impact-attenuating requirements, but they are not accessible because ground surface materials show excessive cross slopes and depressions near and within accessible ground play elements. (Photo 9)

a. If only loose fill ground surface materials are used, implement a high-frequency maintenance program to ensure accessibility of ground surface materials through all seasons.

b. If ground surface materials will be replaced: consider adding unitary surface materials within the playground areas to provide accessible routes and clear ground spaces to all entry/exit points of ground play elements, including swingsets, play structure transfer station, and ground play elements.

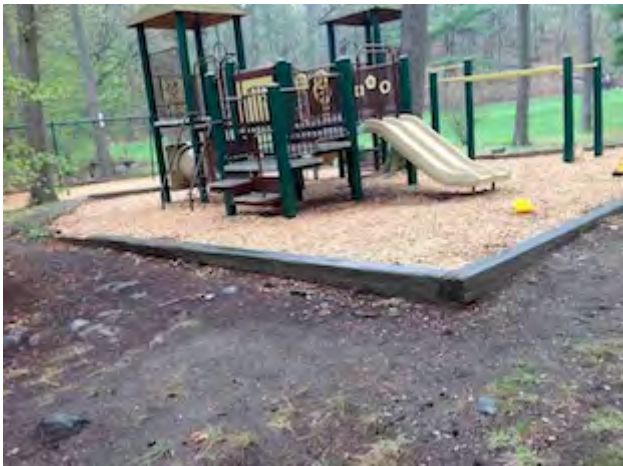
Photo 10

The playground border is a barrier to accessible entry into the play area because it has level changes of between 2 - 8 inches above the trail and there is currently no accessible entry point into the play area. (Photo 10)

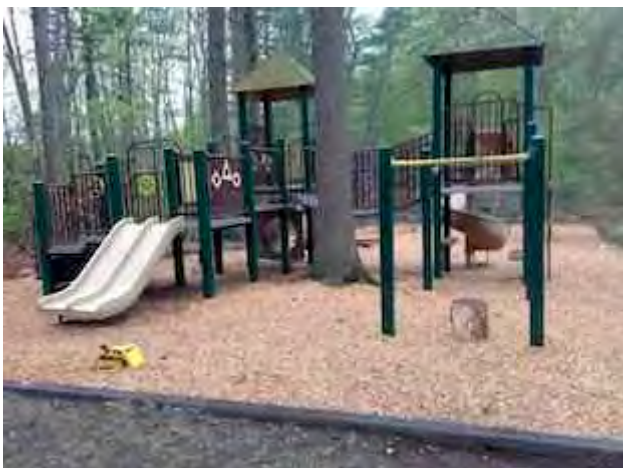
Photo 11

This bordered playground area accommodates a swingset with 50% accessible swings and a large interconnected play structure. There are 4 types of ground play elements and at least 10 elevated elements providing a variety of challenges, including seated slides, pole slides, fort play, interactive panels, swinging. and swaying.

A transfer system provides stepped connection to at least 50% elevated elements, and there is no accessible (ramped) elevated route. (Photo 11)

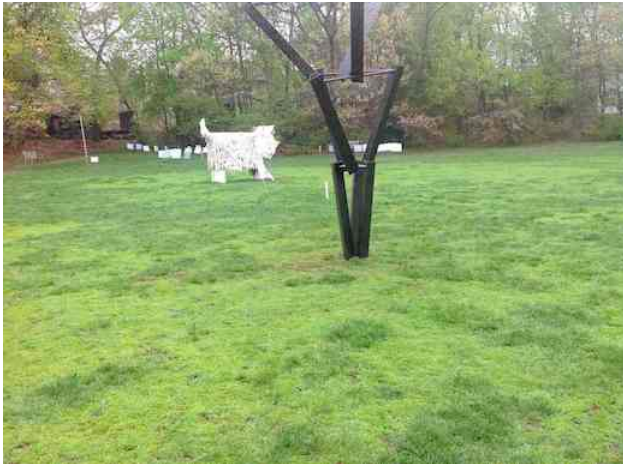
Photo 13

At this Park, there are 2 open fields that are beautiful locations used for informal field games in addition to summer camp and adult programming and community-wide special events. Programming includes adult Tai Chi classes, live theatre (Shakespeare in the Park) and Arts Installations. (Photo 13)

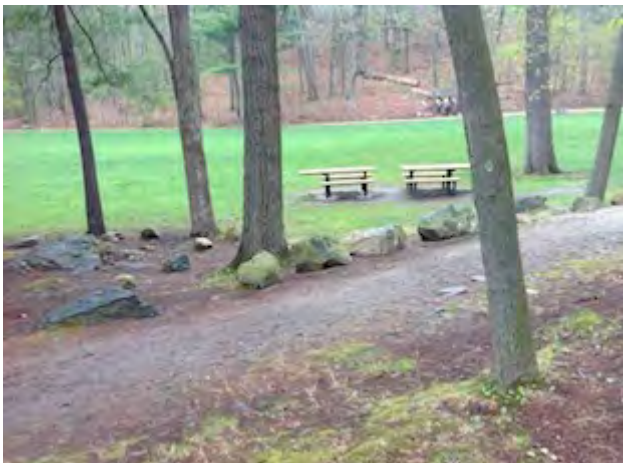
Photo 14

There are two accessible picnic tables provided. These thoughtful tables need to be connected to an accessible path branching off the main graded trail. (Photo 14)

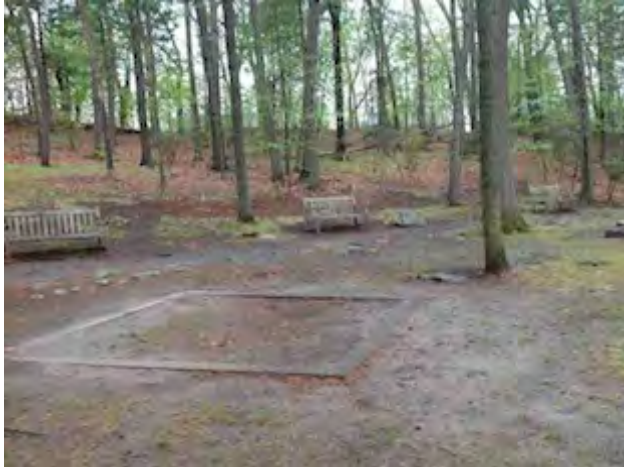
Photo 15

Some wooden benches are not highly visible along the wooded portion of the accessible trail; others, painted green, are easily spotted and along the well graded trail. A best practice recommendation is to repaint faded wooden benches with a color that contrasts with the natural environment.

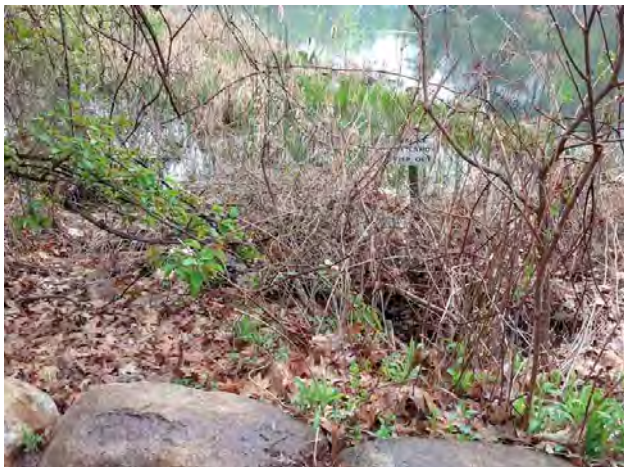
Photo 17

Cautionary signage in the wetlands section of the graded trail is mounted beyond the rocky border and obstructed by vines. Safety and information signage along trail should be inventoried and reposted where it may be beyond viewing distance or obstructed by natural growth. (Photo 17)

Best Practices Recommendations:  
Inventory safety signage along trail and relocate where visibility may be obstructed.

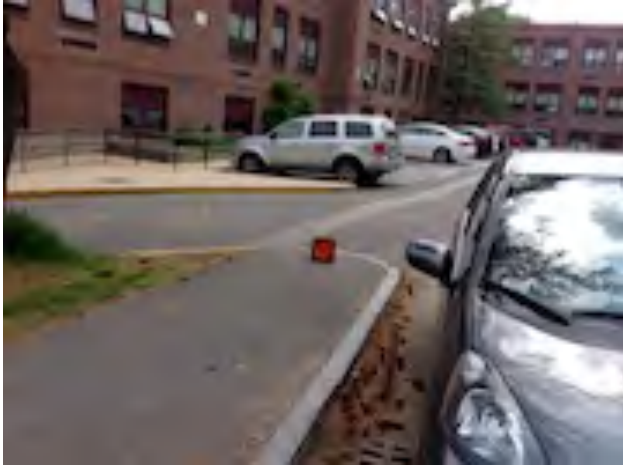
Photo 4

There are approximately 56 parking spaces provided at the parking facility adjacent to this field. Three spaces with two marked access aisles are designated as accessible with ground markings and 2 signs posted on building. A walkway leading to a ramp leads users to the school entry/drop off location. This ramp is not connected via any accessible route to the field. The set of accessible spaces is not connected to any accessible curb ramps or route to approach and use any portion of the field. (Photo 4)

2. Evaluate the walkway and ramp conditions at the foot of the accessible spaces and mitigate excessive cross slopes, gaps, and uneven conditions at this walkway in front of the ramp.

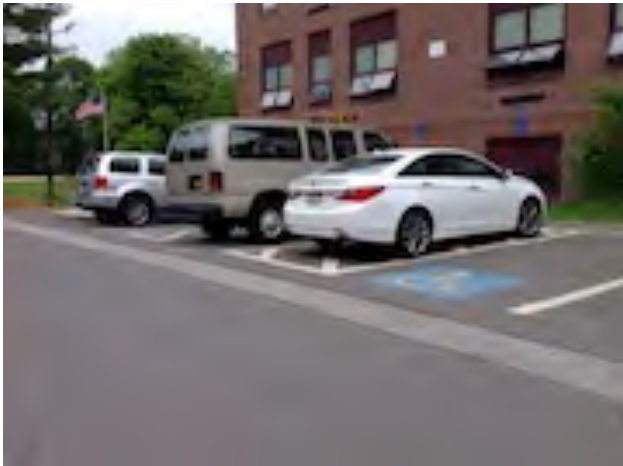
Photo 5

During the field survey<sup>28</sup>, this parking lot was active with vehicles searching for a parking spot. At some point, all cross hatched areas were filled with parked cars. Both access aisles were also in use, although the accessible spaces were not. (Photo 5)

Best practice recommendation: Provide public information on website and in public brochures informing the general public about the need for access aisles to remain clear of vehicles.
